36675 High Meadow Industrial Lane Magnolia, TX 77355 Direct: 281-259-2222 Desalters.com

BUILDING DESALTERS WORLDWIDE

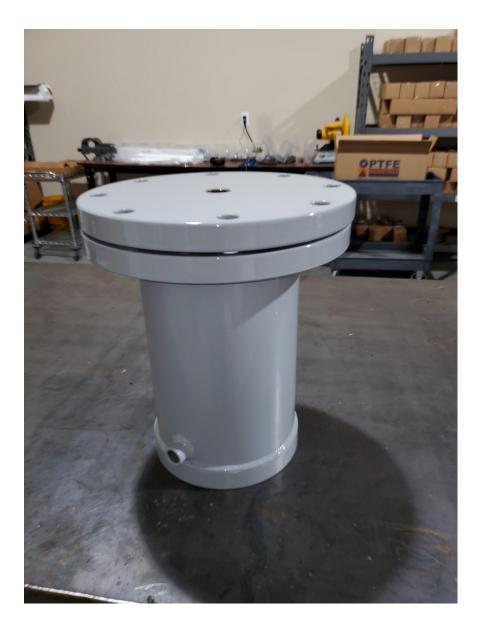
BUSHING HOUSINGS

- Highest quality virgin PTFE
- Superior design with solid CNC machined connection ends for maximum strength and durability.
- Not welded and prone to failure like competition.

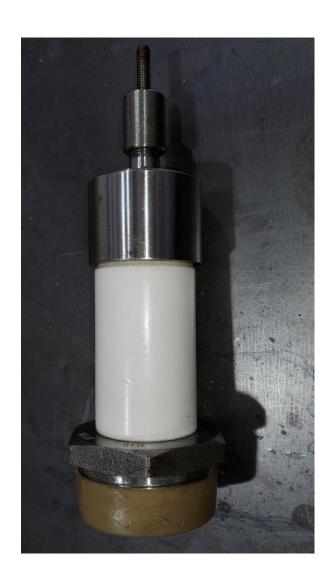
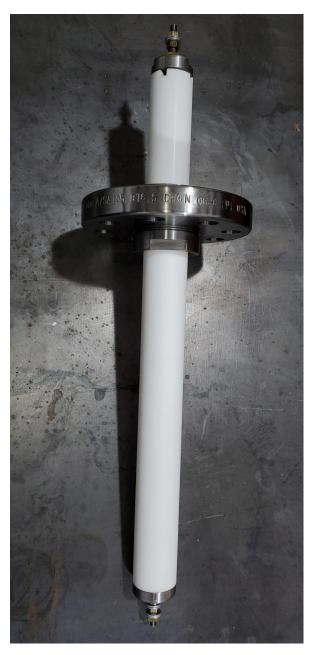
Entrance Bushings

- Highest quality virgin PTFE

- Proprietary design ensures maximum strength and durability

- Provide maximum safety when in combination with Desalters LLC housings and solid conduit connection to transactor.

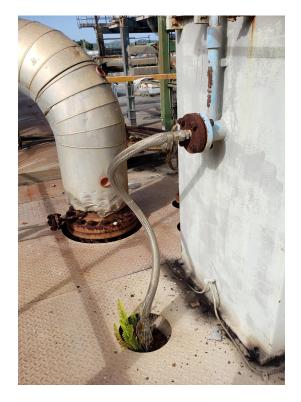
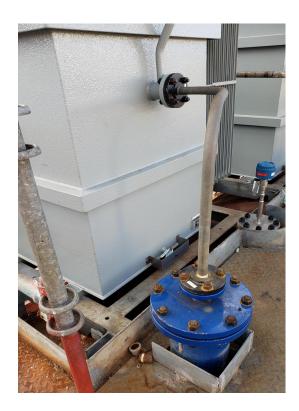
- Combination transformer and currentlimiting reactor
- Non-overloading type
- Full impedance (100%) reactor
- Units designed to NEC Class I, Div. 2,
- Groups C&D, hazardous locations
- Multiple secondary voltage levels can be provided (8-16 KV)
- Transactor rating typically 2-3 times the expected load

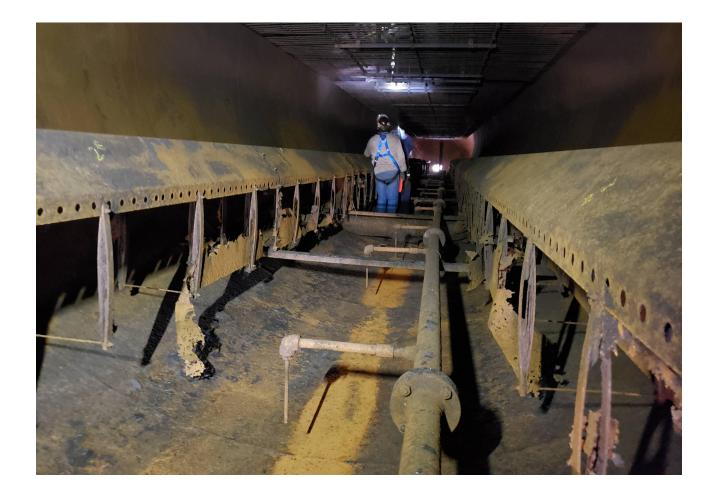
Limetree Bay Refinery- St. Croix (BEFORE)

- 2019 Project
- Five low velocity desalters
- Vessel size- 128' x 14'
- Idle for approx. 9 years
- Required complete revamp

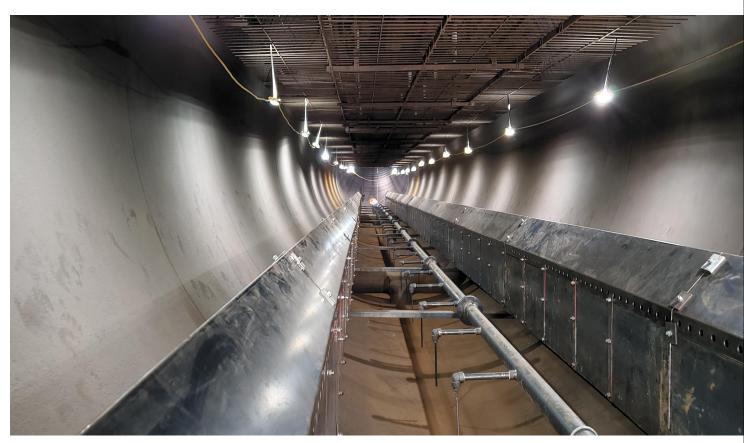
Limetree Bay Refinery- St. Croix (AFTER)

- Total revamp of 3 out of 5 desalters have been completed to date
- 37,000 lbs. of material delivered to site without incident
- Revamp completed in 4 weeks.
- Completion time was 3 weeks ahead of schedule
- Final vessels scheduled for completion 2021.

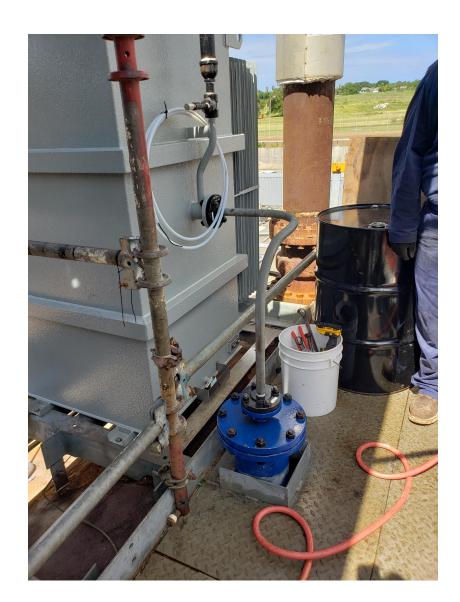
Limetree Bay Refinery- St. Croix

• 250 kvA Transactor, Housing, and Bushing Install

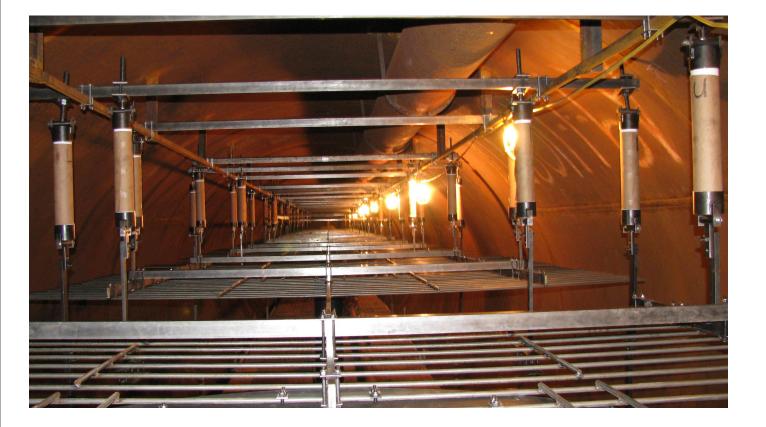
Limetree Bay Refinery- St. Croix

Trident Grid and Bushing Instillation

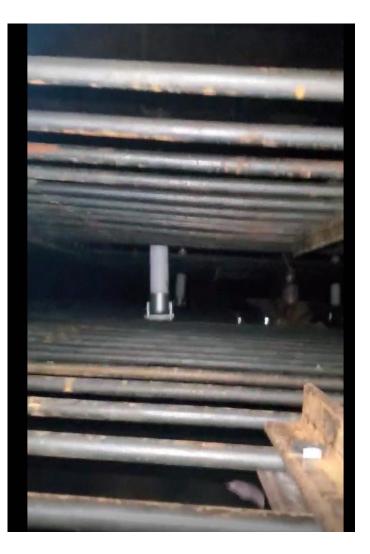
S.I.R- Abidjan Oil Refinery

- 2019 Project
- PETRECO Chem-electric
- Required replacement of electrical grids and electrical components
